## Soil and Groundwater Characteristics of a Legacy Spill Site

**ABSTRACT:** The soil and groundwater of a legacy spill site in Eleme Local Government Authority Area of Rivers State were investigated. The general land use of the area within 1500m radius of the spill site is devoted to farming, fishing and hunting. The main crops grown include yams, cassava, maize, sugarcane, plantain, banana, oil palm, coconut, raffia palm. Families own the land and this ownership is by inheritance. In recent times, people can purchase land for use and others can also hire. The stratigraphy of the subsurface at the study site is closely related to the local geology of the site. Basically, the local geology is that of the coastal plains sands. Generally, the water table at the study area ranges from a low of 0.0m (at ground surface) to a high of about 5.10m. Where it occurs within the subsurface, the groundwater was observed to occur either within the lower part of the sandy clay or within the sands and gravels layer. The general direction of the groundwater flow within the area was observed to be from the North West to the South East. Underground pollution plumes were also in this general directio

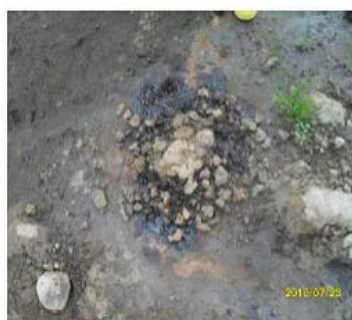
Fig 2: Visible oil seepage on the soil surface

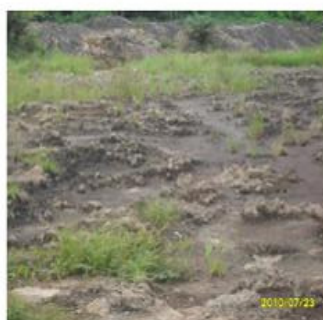
During the spillage, the crude oil ignited and burned for several days before the fire was brought under control. As a result of the fire, a layer of burned, carbonised residue has formed a crust on the surface of the site between the pipeline and surface-water pond approximately in the centre of the site. Photograph of the site are displayed below showing pile of surface material that had been scrapped by others from the North-West area of the site.

Fig 3: Caked soil at the site

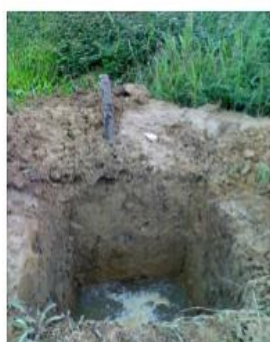
Figure 5: Trial pit for soil profile determination

**Test Pitting:** Twenty-three (23) trial pits were dug with the aid of Spade and Hand trowel. All trial pits were completely backfilled with the excavated material after completion of all investigations for and sampling for soil profile using the Unified Soil Classification System (USCS), visual observations, the presence of fill or reworked material; field headspace screening measurements, the presence of moisture, product, staining and odours, and any other observations relevant to the investigation of potentially impacted soil.

**Field Observations:** A total of 23 trial pits and 10 exploratory holes were dug at the study site for the site assessment (typical trial pit in Figure 5).

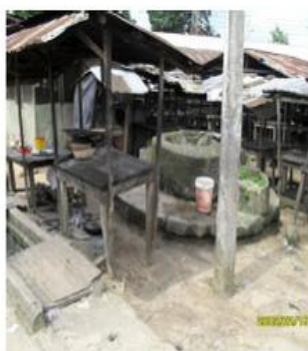
Figure 6: Existing Community Well

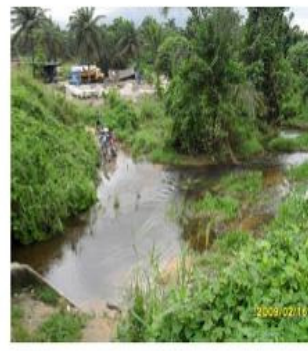
Figure 7: Section of the Ochani Stream

At the central area is a pond which flows into the Ejama-Ejor stream. The Ejamah-Ejor stream connects with the Kuleke stream which subsequently flows into the Ochani stream. The Ochani stream stretches through the East West Road follows a course of rivers into the sea. Beyond the central pond is a swampy area with degraded crude oil visible in the wet land.

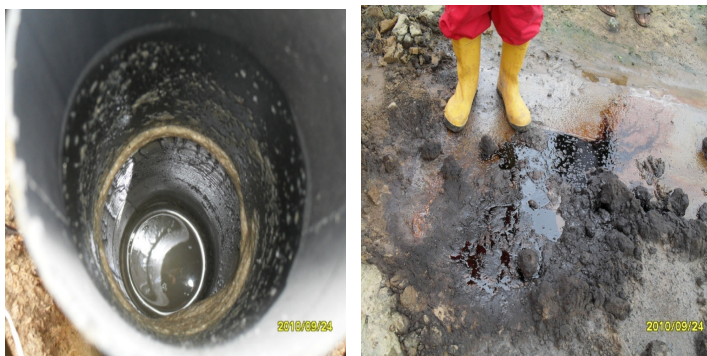
Fig. 8: Top view of exploratory borehole      Fig. 9: Oil seepage hotspot near exploratory well

General Information on Exploratory Well	
B/Hole depth(M)	18
Casting depth (M)	0-14
Gravel Pack (M) screen depth	14-17.5
Sand Tilling	0-13
Depth from casting to ground surface (M)	0.08
Depth from ground surface to water table	5
Gravel pack depth (M)	13-17.5
<b>Soil Description with Depth:</b>	
1.2m of soil is brown to dark due to oil impact.	
4m of sandy grey clay with silt intercolations	
2.5m grey brown clay	
3.5m fine/medium coarse white grey (Screen zone)	
2m white clay thick and compacted	
<b>Observations:</b> Oil film on top of water is 2.5cm
